# NAVRONGO CATHEDRAL

The merge of two cultures

**"Our Lady of Seven Sorrows Cathedral" was constructed in 1920 following the arrival of French Canadian missionaries in Navrongo. It was the first large building in the area, but its uniqueness also stems from the fact that it is a major witness of the history of the encounter and merger of two cultures: the Roman Catholic and the Nankana / Kasena.**

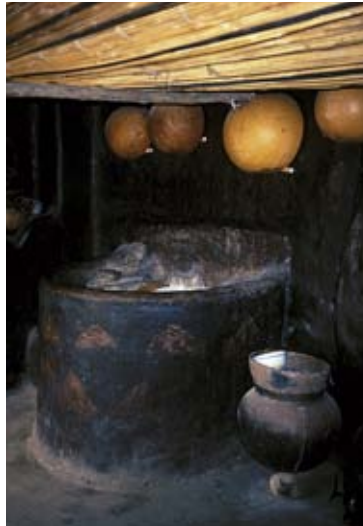
Above the grinding platform are hanged a collection of calabashes.

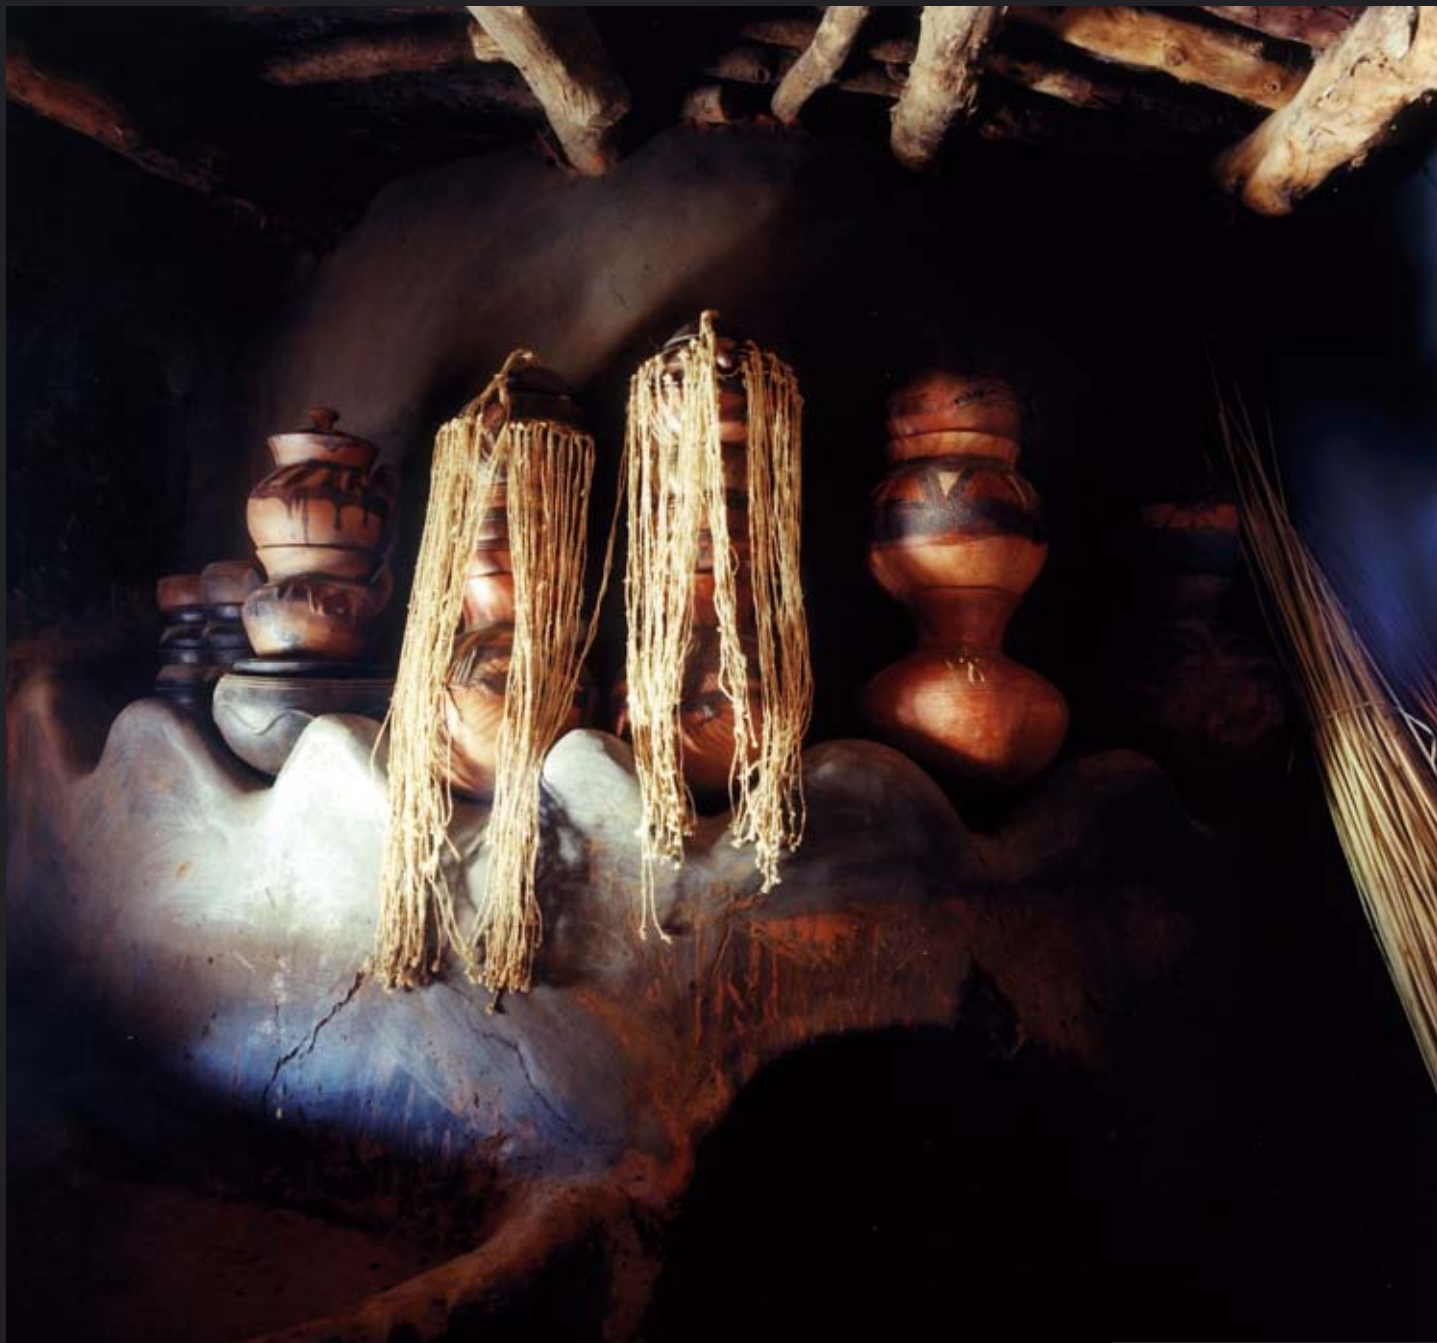
The woman's traditional interior quarters holds her prized pottery collection.  
*Photography Marie Schuiten*

The semicircular serrated "sideboard" with rounded depressions stands out as the most striking feature of the traditional woman's interior quarters. It holds a woman's prized pottery collection. The grinding platform is composed of two granite stones: the various grains are first roughly ground, and then, if necessary, ground again on the smoother stone for a finer texture. Sleeping mats are rolled and stored on rafters suspended from the ceiling beams.

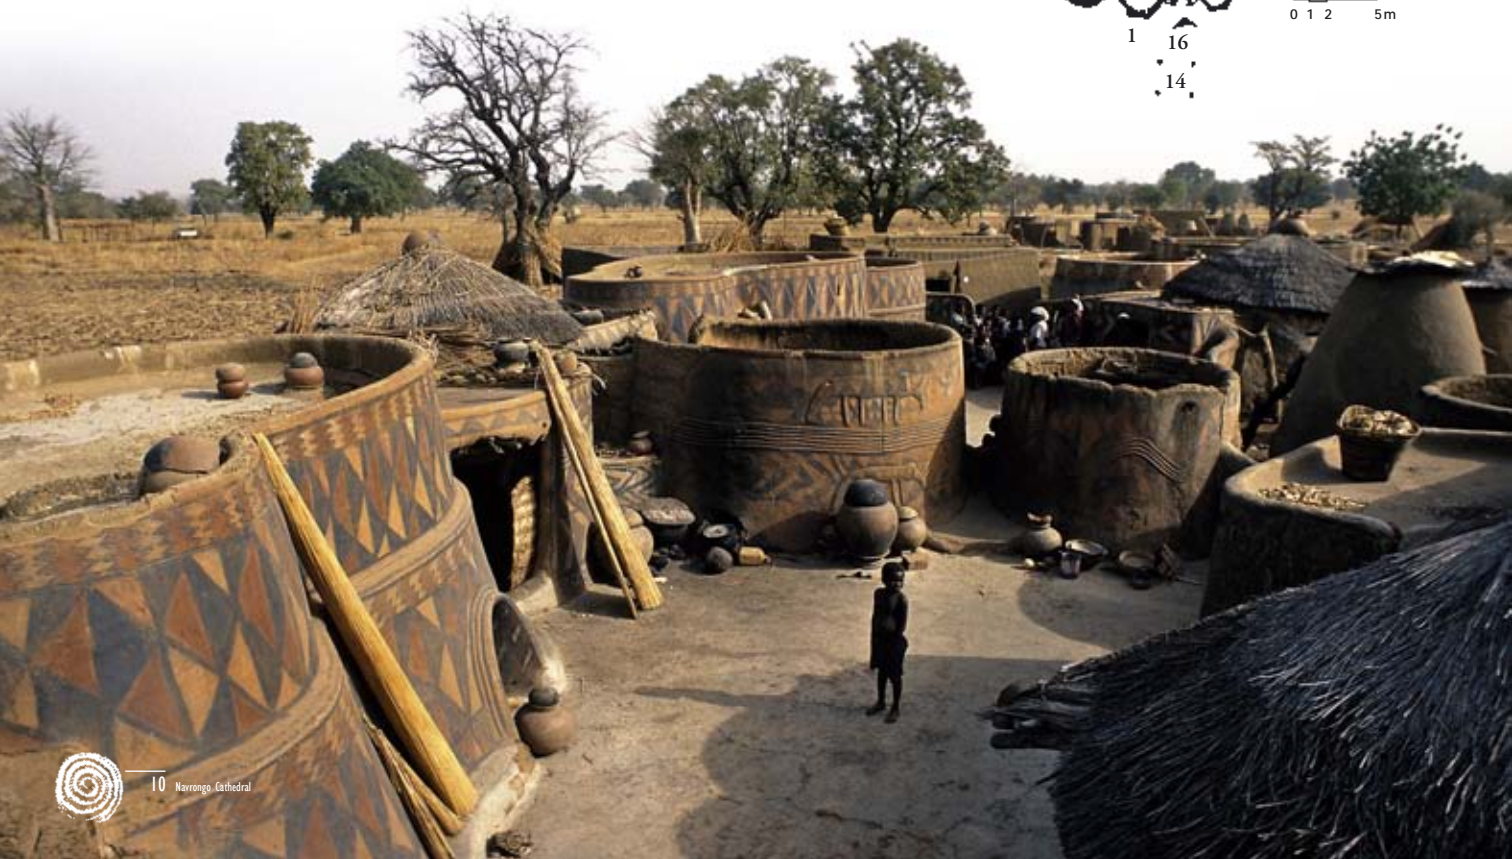
**ADONO'S COMPOUND (NANKANI)**

1. *BAGÈRÈ*: shrine
2. *BANRÈ*: small granary
3. *BONGA SONGO*: donkey pen
4. *BONGO*: a man's sleeping space
5. *BOPAKA*: a man's reception space serving as an antechamber to the BONGO
6. *DANGA*: outdoor cooking space covered with millet stalks
7. *DÈGO*: a woman's sleeping-storage space

8. *DĒTINĒ*: thatch-roofed space for an unmarried man or woman
9. *GONGONGA*: open exterior cooking area used mainly on occasions when much cooking is needed
10. *ISOARGA*: bathing enclosure
11. *NANDĒNĒ*: cattle kraal
12. *KUKULO*: a woman's granary
13. *POKA DAPURĒ*: semi-public sphere in which women grow okra, sorrel, beans or millet

- 14. **PONGA**: shelter where the senior man rests and receives his visitors during the day
- 15. **SARAGA**: indoor cooking space
- 16. **TALANGA**: area in front of the compound entrance
- 17. **VANANA**: small packed-earth court
- 18. **YANGA**: doorway of the compound
- 19. **ZINZAKA**: packed-earth court
- 20. **ZONGO**: thatch-roofed pens for goats and sheep

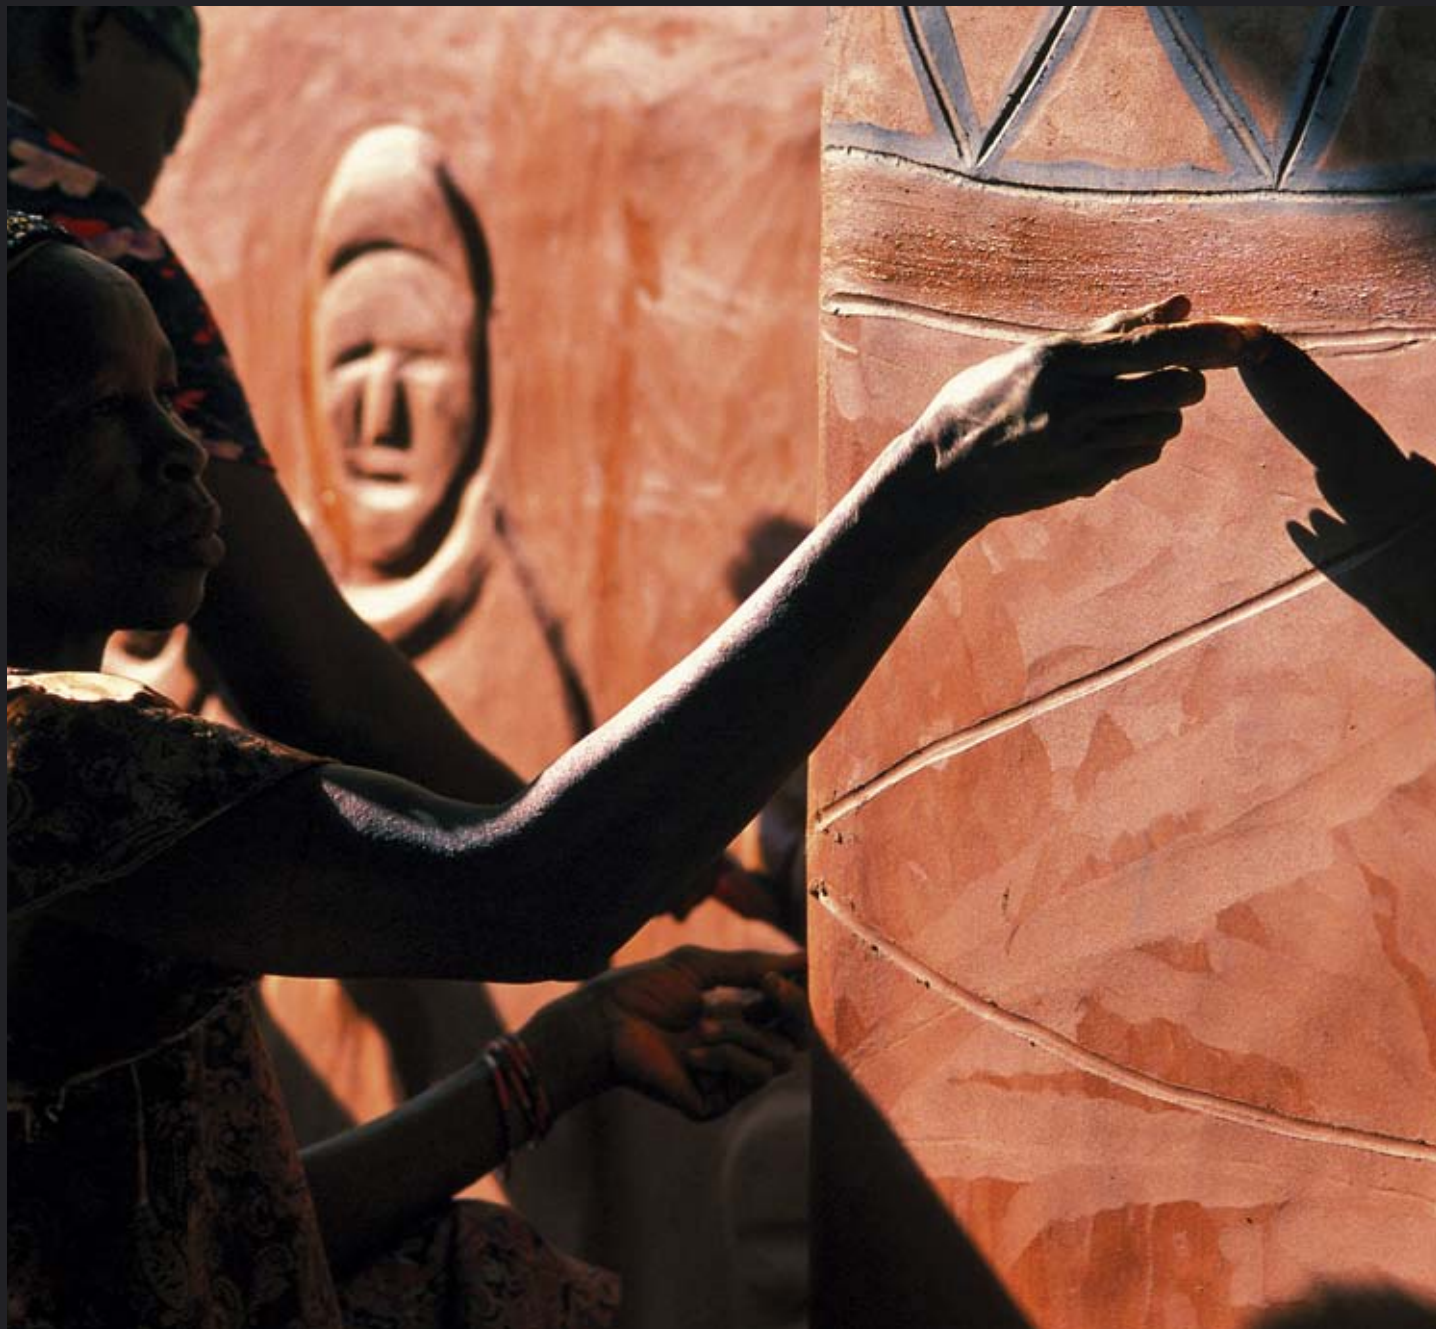
With her smooth stone, the artist incise the still wet and soft decorated mud plaster.

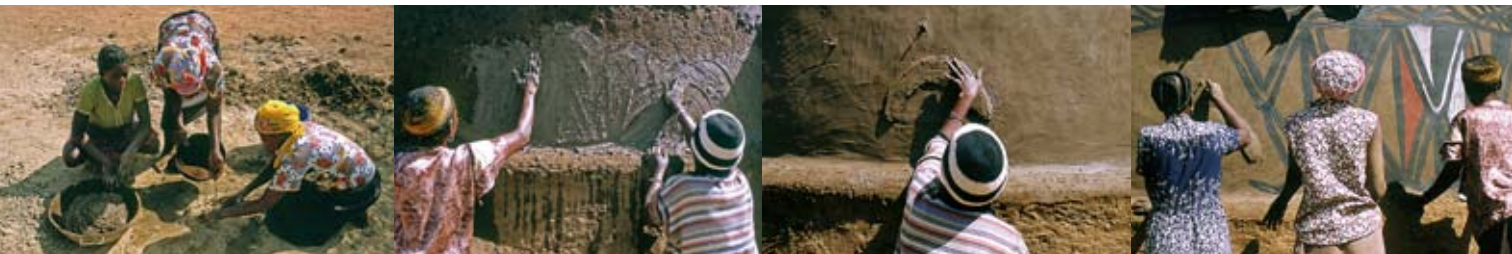
The soft white earth, "gora", which is used for the first layer of the plaster, has to be sifted to remove all vegetal matter as well as small stones.

The first layer is applied with the hands and reliefs are shaped. Then, the surface is covered with a mixture of water and cow dung, and evened

with a flat stone. On the still wet plaster, a thin layer of red laterite earth and cow dung is applied with a grass broom. This second layer is smoothened with a stone. A woman usually has a set of stones of different shapes and sizes. A good stone has an egg shape with a flat side. It allows to flatten surfaces, to fashion curves of the relief, or to incise the surfaces.

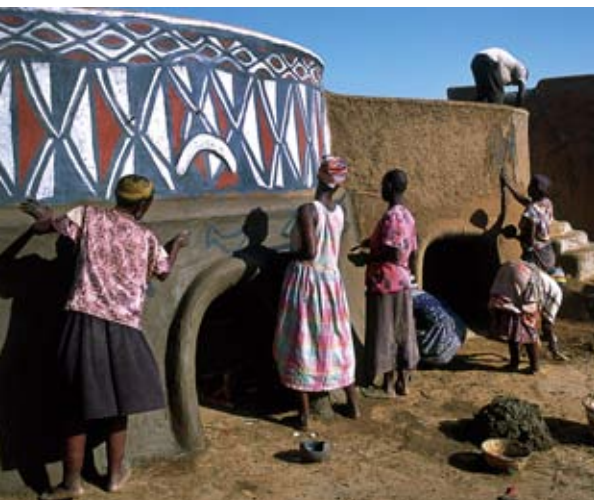
The motifs are painted in horizontal registers, starting at the top of the wall. The outlining of the designs is done in black and the spaces created are filled with either the black or dark red paint, or rubbed with the white talc stone. After the composition has been completed, the whole surface is smoothened again, colour by colour, line by line, space by space so as to avoid smudges. The wall is left to dry up to the right moisture content of the plaster. Then, it is polished once more to an extremely soft and shiny finish.

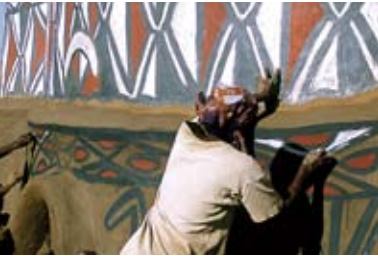
“KUG PEELA”. At market where they are sold in piles of three or four, the smooth white talc stones are chosen meticulously for their purity. They are rubbed over the red laterite plaster surface giving a white chalky layer.

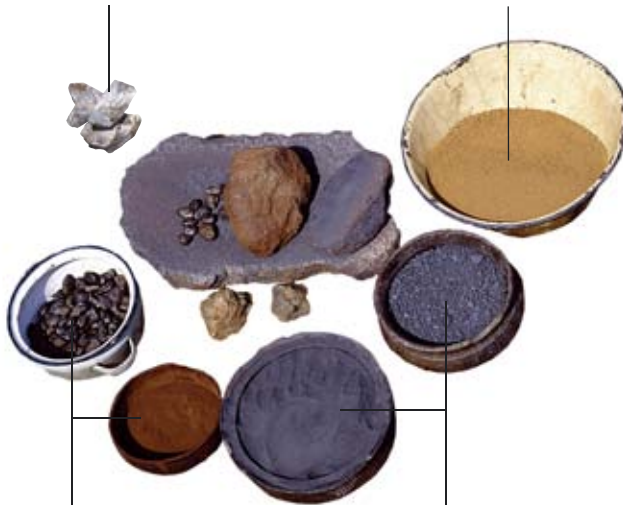
“GARE”. These dark red pebbles are collected along the road side outside of Sirigu in a town called Yua. Once this red mineral pigment is reduced to a very fine powder, it is added to a mixture of water and cow dung giving a rich dark red paint.

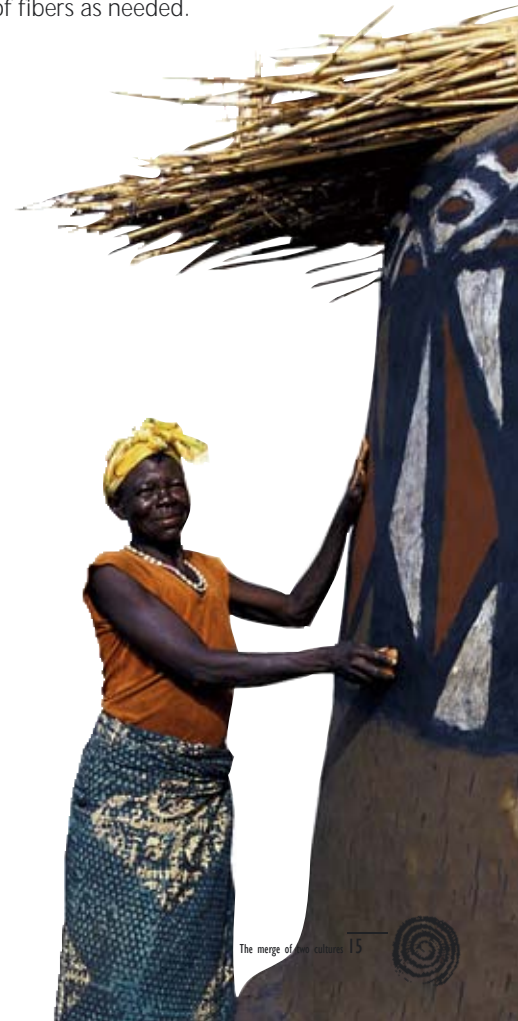
The designs made of abstract geometrical shapes are usually painted on a flat surface. The stylised figures - humans, animals, objects - are fashioned in relief highlighted with abstract geometrical forms and can be incised.

A common repertoire of about ten painted motifs was identified in the traditional compounds. The prevailing shapes are triangles and lozenges, and the patterns are usually applied in horizontal registers.

1. ZAALINGA - WAALINGA is the traditional rope net used to stock calabashes
2. AKUN - NYANANII means "someone has many cattle".
3. TANA - SOKARGA symbolises men's cloth or old broom.
4. WANZAGSI means "broken calabash". It symbolises the usefulness of the calabash.
5. APILIGIYETA - Kin kili book represents the wings of a bat.

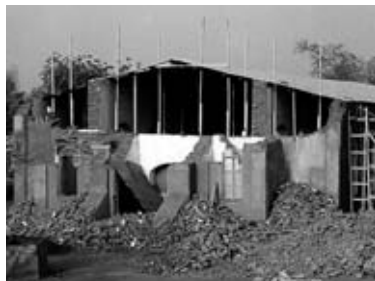
Despite these renovation works, some cracks in the bell tower and the falling down of some facing bricks protecting the eastern elevation of the bell tower started to worry the administrator of Navrongo Mission. Following the advice of the Ghana Museum and Monuments Board, the bell tower was dismantled and its re-construction started, respecting the original shape.

This re-construction was handled by a mason who had been taking care of the cathedral for a long time. His good knowledge of traditional techniques allowed him to imitate the existing methods. But nothing was done to avoid the repetition of previous decay processes.

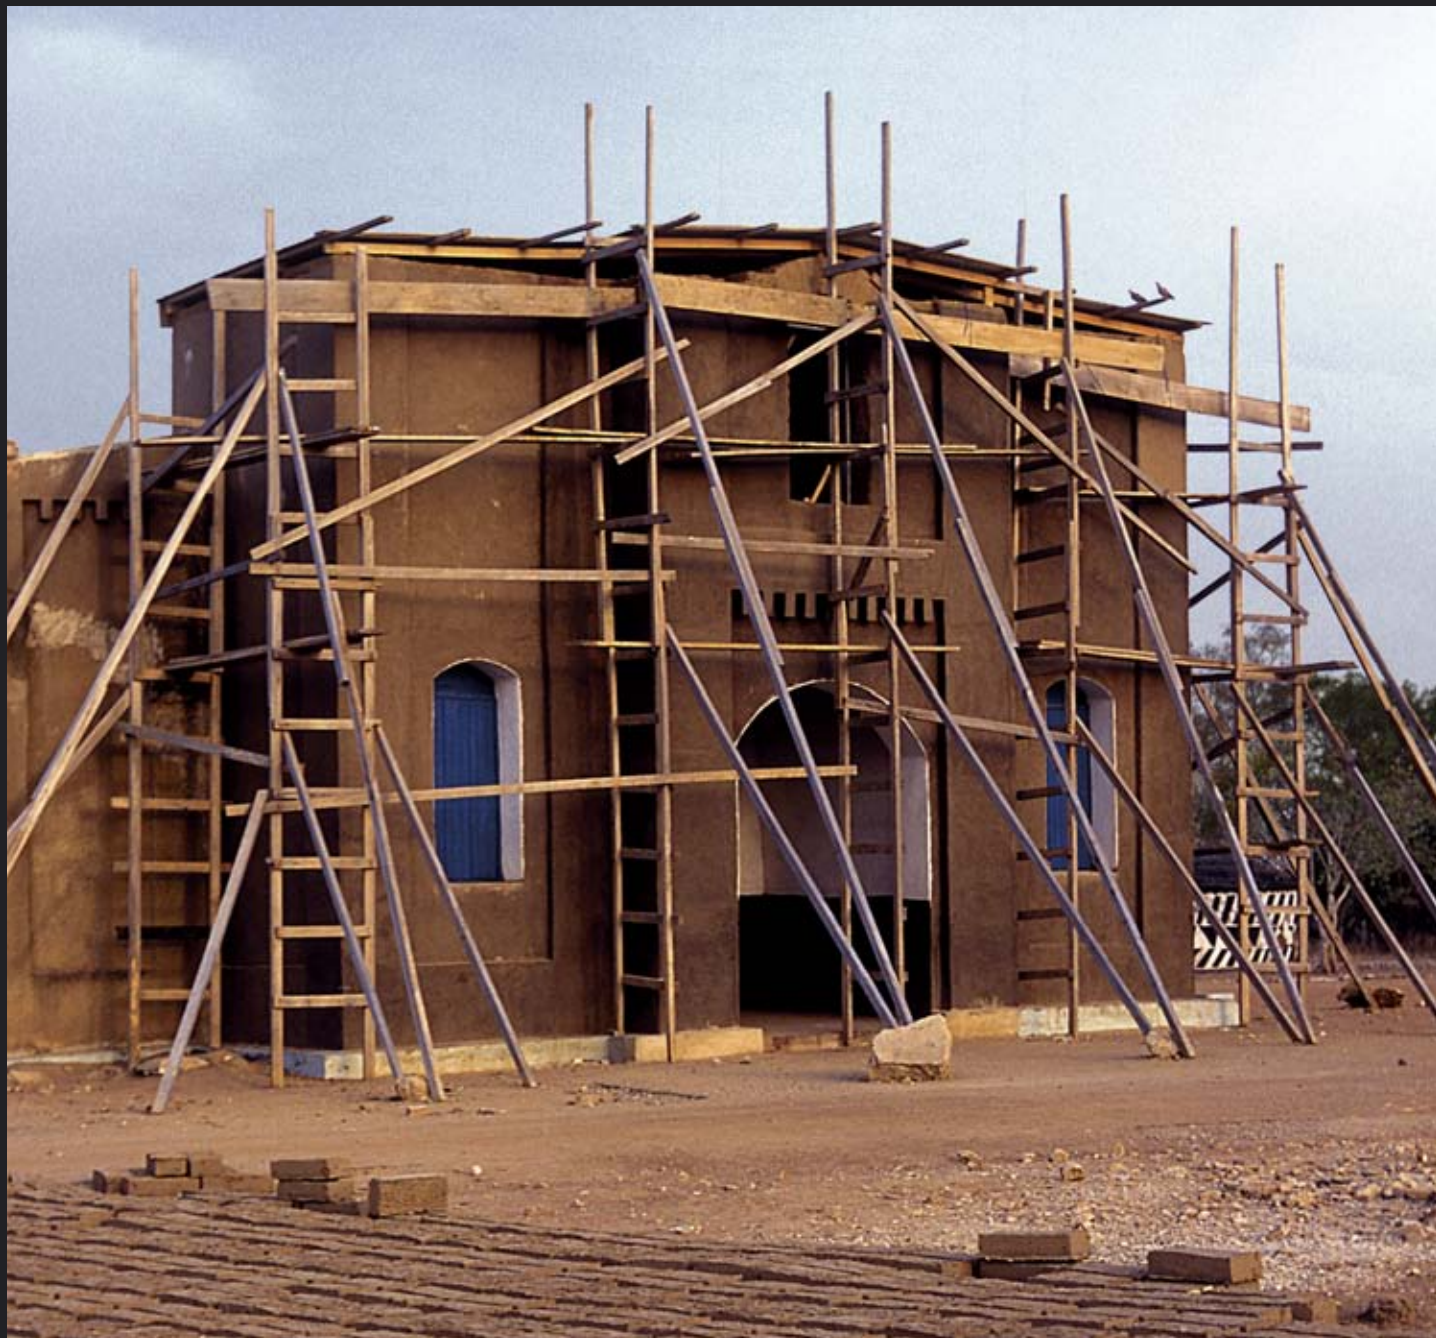
Reconstruction of the bell tower in january 1997

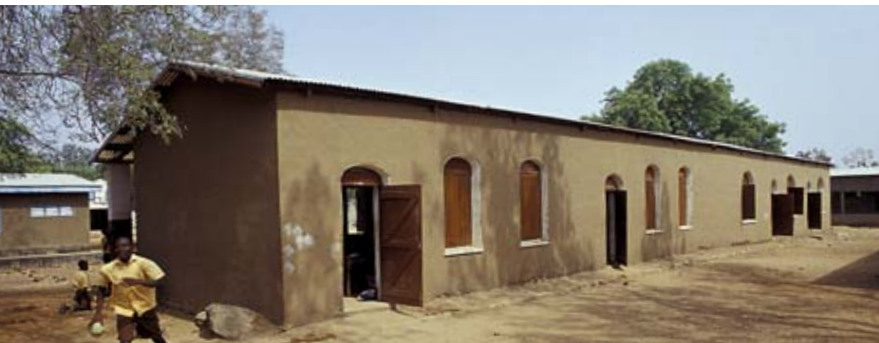
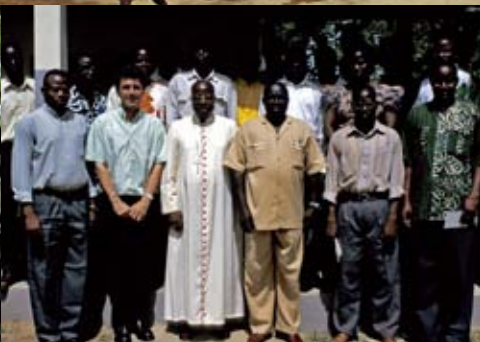
Old classroom block, before and after rehabilitation

Therefore, in addition to the restoration of the cathedral, it was decided to develop complementary activities. These included the rehabilitation of an old classroom block, and the construction of a new structure, the museum, wich would then also serve for demonstration purpose.
